Checking the Hydraulic Pump Drive Pulley Hardware on IS5100Z Models

Ferris has determined that the hardware securing the hydraulic pump drive pulleys may not have been tightened to the correct torque specifications on the units detailed below. This details a procedure for inspecting the hardware and tightening the hardware if necessary.

MODEL NUMBER	DESCRIPTION	SERIAL NUMBER RANGE
5901282	IS5100ZC33D72	2016929289 - 2016937279
5901283	IS5100ZC33D72RD	2016929289 - 2016937279

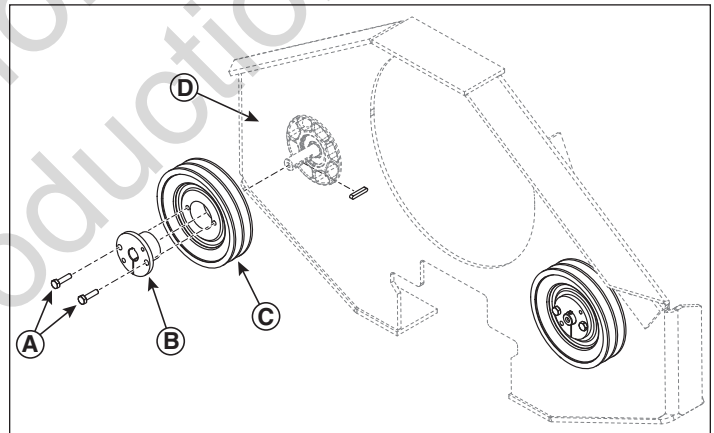
Figure 1. Checking the Torque of the Pulley Hardware
A. 1/4-20 x 1" Bolt
B. Tapered Hub Bushing
C. Hydraulic Pump Drive Pulley
D. Pump Plate Weldment

1. Park the unit on a flat, level surface such as a concrete floor. Disengage the PTO, engage the parking brake, turn the ignition switch to OFF, and remove the key from the ignition.
2. Release the hood latch and raise the hood until it locks in place.
3. Remove the rear belt shield.
4. Using a 7/16" socket and a torque wrench, set the wrench to 120 in. lbs. (13.5 Nm) and check the torque of the two 1-4" bolts (**A, Figure 1**) on both tapered hub bushings (**B**) that secure the hydraulic pump drive pulleys (**C**).
5. If the bolts need tightening, alternate tightening the bolts back and fourth until you reach the correct torque specification.

NOTE: The hydraulic pump drive pulleys (**C**) should be spaced approximately 5/16" off of the pump plate (**D**).
